Kiwi Feather Props Ltd

CUSTOMER MANUAL

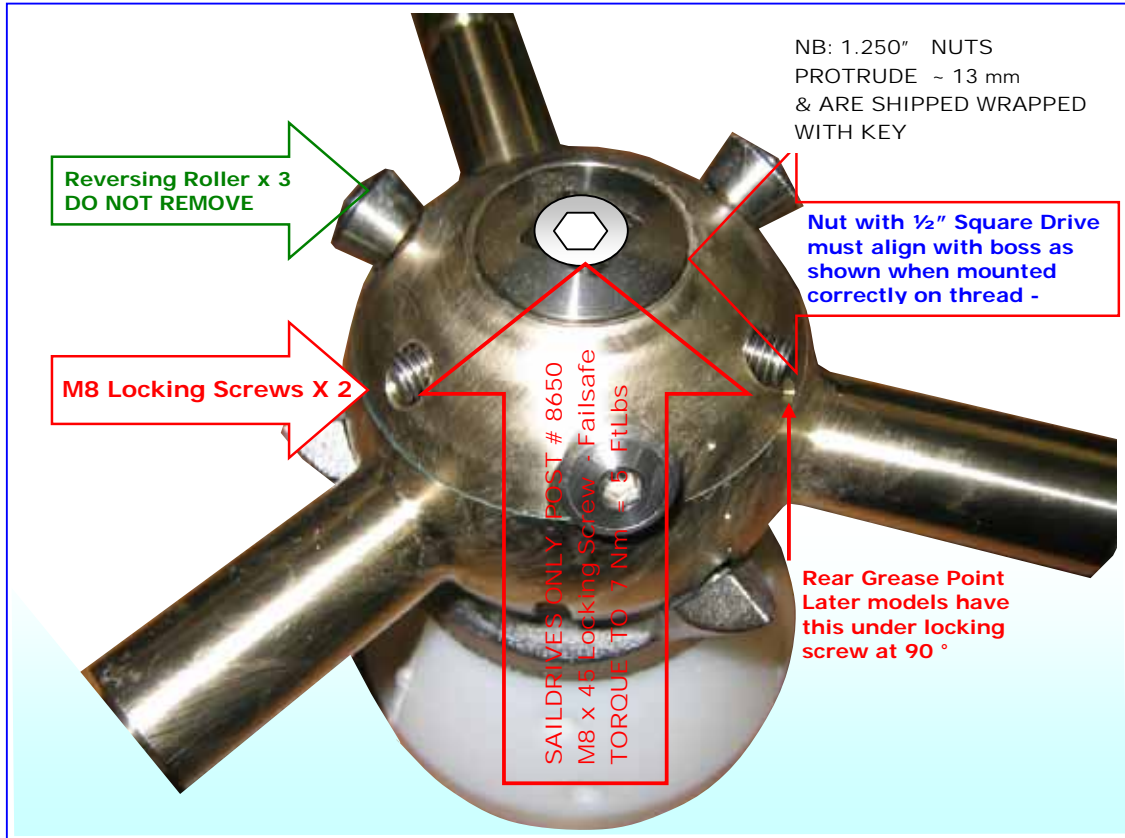
The photograph below shows a boss without the blades attached and clearly identifies the nut with its ½" square drive recess and the two M8 locking screws that must first be backed off to allow for removal of the nut from the unit.

Remove the 2 x M8 locking screws. Coat all thread surfaces in Loctite™. Insert into boss and only tighten down securely once the nut retaining the propeller is correctly locked in.

NB: A FAILURE TO TIGHTEN THESE TWO LOCKING SCREWS AND SECURE ALL THREADS WITH LOCTITE™ CAN LEAD TO THE LOSS OF THE ENTIRE PROPELLER UNIT OVER TIME ON A SAILDRIVE UNIT. THIS IS NOT SO CRITICAL ON A TAPERED SHAFT MOUNTING.

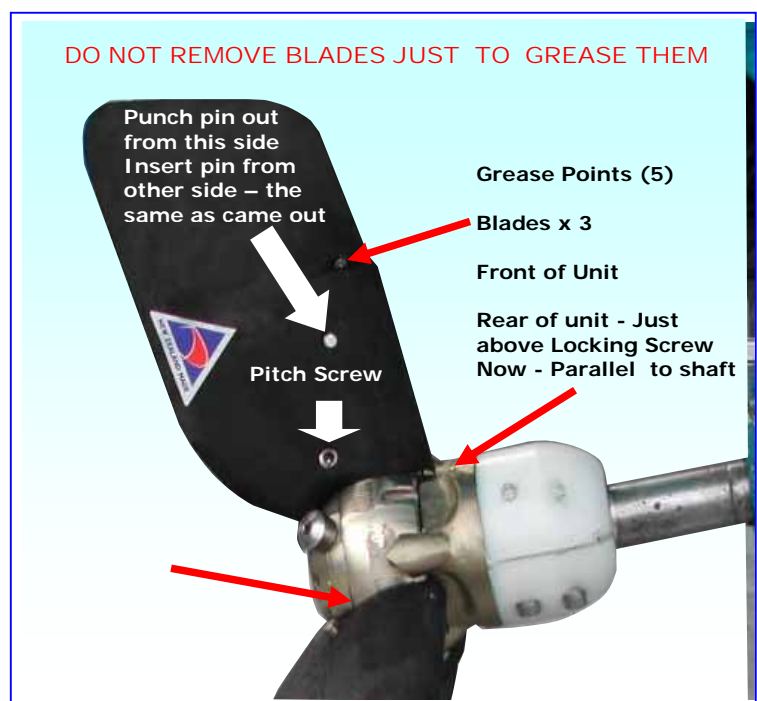
The *Kiwi Feather Prop™* contains lubricants sufficient until your next maintenance haulout. Each blade must then be greased via a lubrication point accessed by removing the small Pozidrive stainless screw on the blade face. In addition there are two small grease holes, one very close to the Delrin™ nose cone in the bronze casting that takes the thrust of the pitch screws and one near the outer perimeter of the bronze sphere at the rear of the unit. These have been chamfered to accept a standard needle nosed grease point. You will need to remove the outer guard off the needle. Each of these five grease points should then be filled with a high quality marine grease eg Shell™ Nautilus Marine Grease - NLGI No 2 or Mobilgrease XHP 222

Check the reversing rollers are free to turn and free up if necessary

Check the blade has been remounted on it's old pin. Now mount the retaining pin back into the reverse face of the blade from the side it came out of with a new wear face on the pin facing outwards. By tapping gently - reinsert the pin so that it is equidistant from each outer face of the blade. Refer photograph above for illustration.

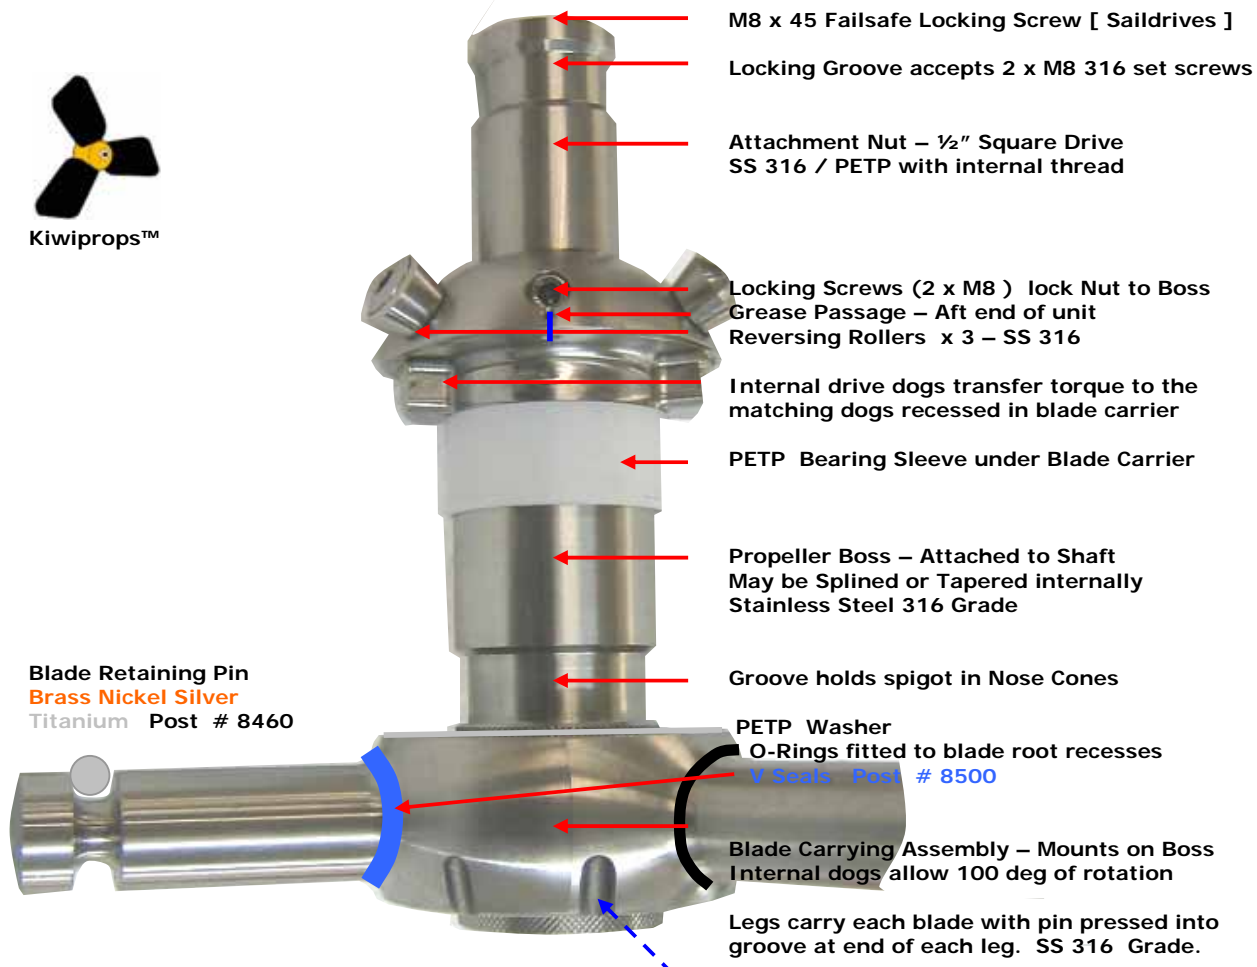
M8 x 45 Failsafe Locking Screw [Saildrives]
Locking Groove accepts 2 x M8 316 set screws

Attachment Nut – ½" Square Drive
SS 316 / PETP with internal thread

Locking Screws (2 x M8) lock Nut to Boss
Grease Passage – Aft end of unit
Reversing Rollers x 3 – SS 316

Internal drive dogs transfer torque to the
matching dogs recessed in blade carrier

PETP Bearing Sleeve under Blade Carrier

Propeller Boss – Attached to Shaft
May be Splined or Tapered internally
Stainless Steel 316 Grade

Groove holds spigot in Nose Cones

Legs carry each blade with pin pressed into
groove at end of each leg. SS 316 Grade.

Blade Retaining Pin
Brass Nickel Silver
Titanium Post # 8460

Refer first to exploded diagram on page 9 below and to the picture of the boss on page 2

Ensure the alignment marks are now correctly located as per the diagram on page 9.

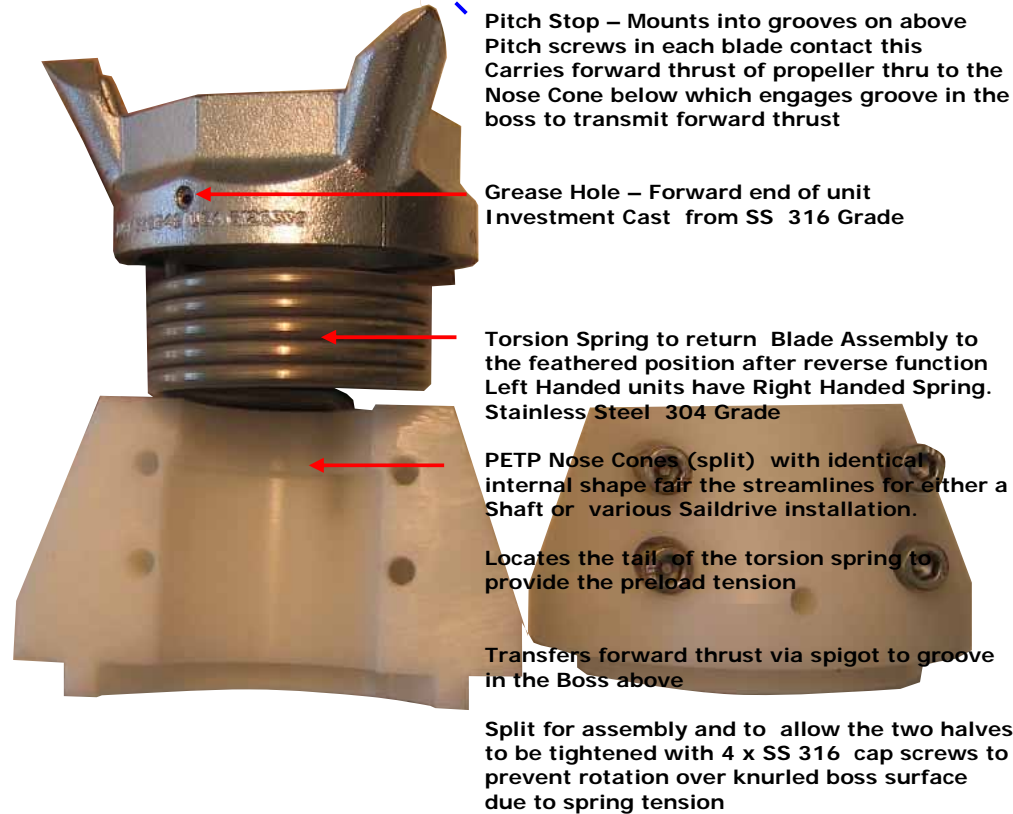
Pitch Stop – Mounts into grooves on above
Pitch screws in each blade contact this
Carries forward thrust of propeller thru to the
Nose Cone below which engages groove in the
boss to transmit forward thrust

Grease Hole – Forward end of unit
Investment Cast from SS 316 Grade

Torsion Spring to return Blade Assembly to
the feathered position after reverse function
Left Handed units have Right Handed Spring.
Stainless Steel 304 Grade

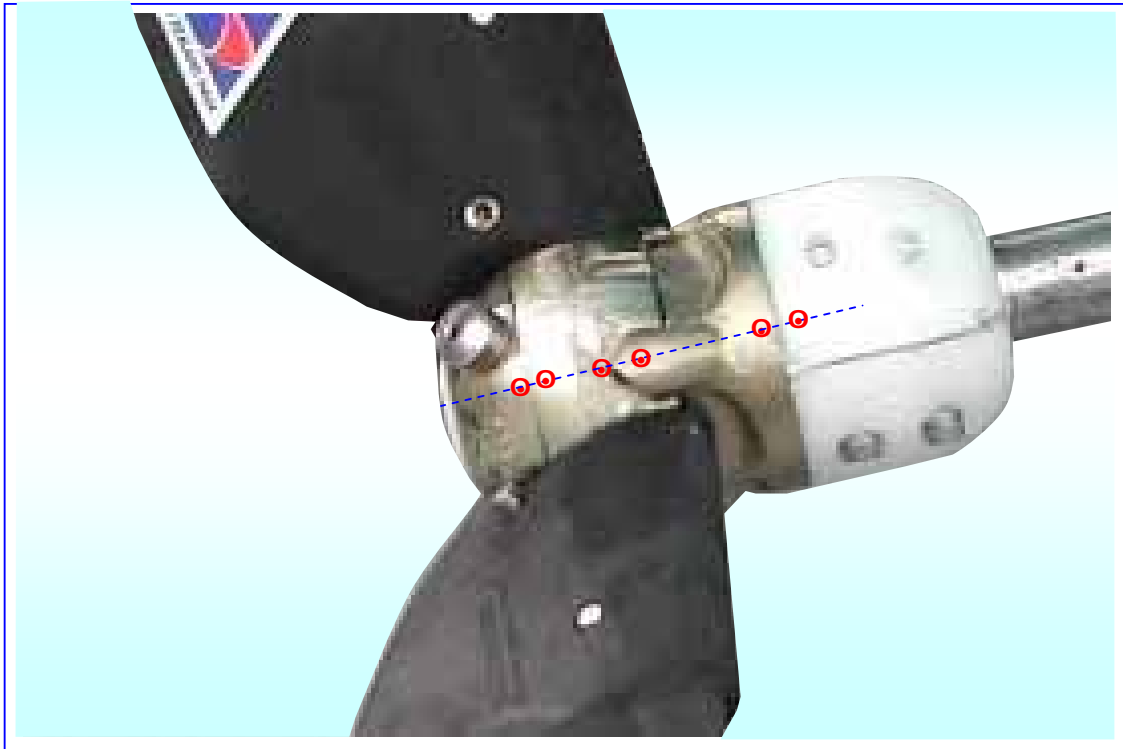
These extend from the Boss to the Blade Carrier down the leg of the tripod that is in line with these marks and then to the small hole drilled just as an indentation on the nose cone adjacent to the mark on the tripod.

The correct re-assembly of the unit will require that all these marks are re-aligned after final assembly including the correct pre tensioning of the torsional spring inside the unit.

WARNING: Customers are strongly advised not to attempt to disassemble the unit unless this becomes absolutely essential. Re-assembly of all the components coupled with the need to ensure sealant is inserted into the nose cone whilst at the same time preloading the internal torsion spring makes for a tricky operation, particularly if no stub shaft is available to hold the unit whilst these operations are completed.

In the absence of a stub shaft to hold the unit during assembly - it will be necessary to mount the unit on the actual shaft or spline which can then be locked by engaging the gearbox
